# ***Why we need... a bridge at Pitkins Curve and a rock shed at Rain Rocks***

Highway 1, 0.5 mile north of Limekiln Creek and 1.5 miles south of Lucia, on the Big Sur coast,  
Monterey County, California  
05-MON-1 PM 21.3/21.6; EA 05-0E9600

Prepared by State of California  
Department of Transportation

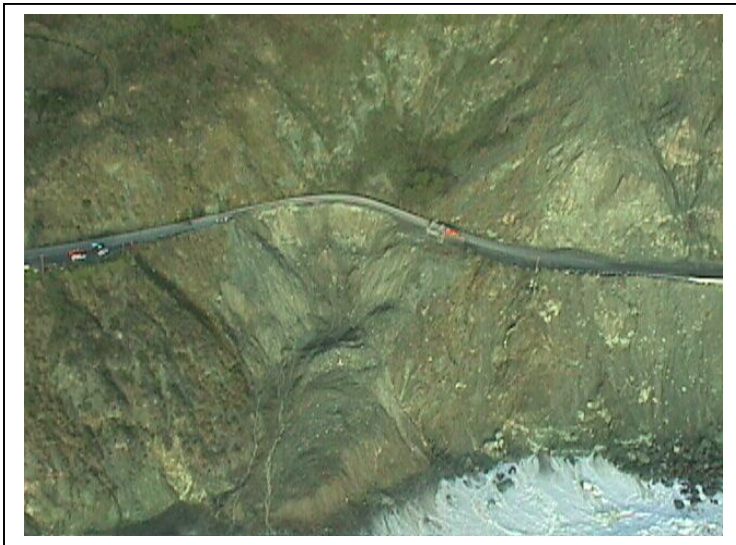
The 1998 El Niño storms caused the most damage to the Big Sur Coast Highway in its history. At Pitkins Curve, landsliding below the highway undermined the southbound lane. Highway restoration cost \$1 million and disrupted traffic for five months. El Niño also activated rockfall at Rain Rocks. To ensure safety for travelers and highway workers, the

Rain Rocks slope was covered with a wire mesh rock net. This cost \$1 million and disrupted traffic for 20 days.

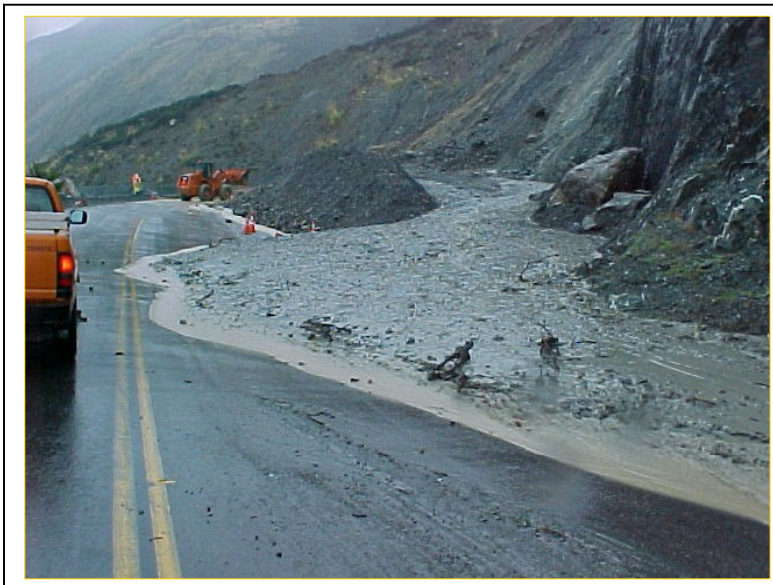
Winter storms in 2001 triggered landsliding above Pitkins Curve and intensified rockfall at Rain Rocks. A catchment ditch and an earth berm were constructed to contain landslide material until it could be trucked away. A portion of the rock net at Rain Rocks was replaced with a stronger cable mesh. Traffic was disrupted for two months and 1400 truckloads of material were removed from the highway at a cost of \$1.5 million.

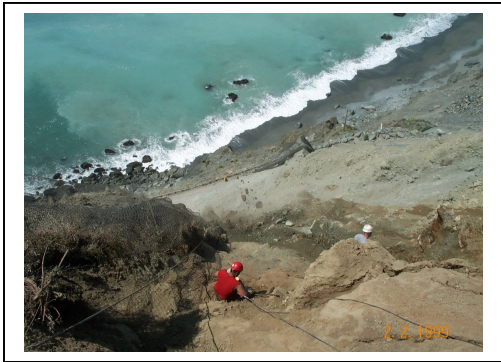
Highway workers often work under hazardous conditions while maintaining Pitkins Curve/Rain Rocks — scaling cliffs with technical equipment to knock down precariously situated boulders from the hillside and using mechanized equipment to scoop up rocks that have fallen behind the protective berms. These activities place them in the

most active rockfall areas. Extraordinary precautions must be taken to ensure worker safety. Exposure to rockfall in high, and Caltrans highway workers have reported numerous rockfall-related accidents.
